X-Brake Series Version

Fitting Instructions

Thank you for choosing to buy the original X-Eng Disk Transmission Brake conversion for Series Land Rovers.

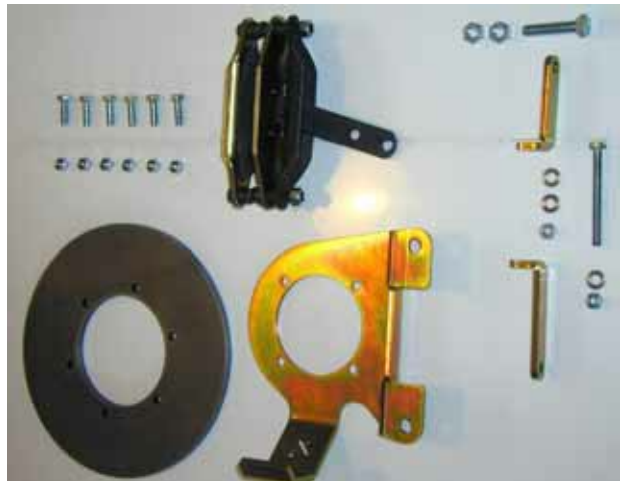
This is the kit of parts you should have received. Additionally, there is one 35mm M8 Bolt, three washers and a nylock nut that we only discovered you need after the photo was taken!

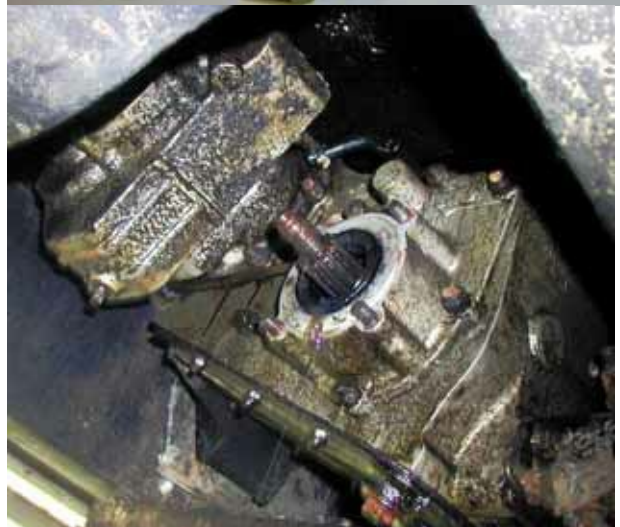
The first step is to remove your existing handbrake assembly. There is a metal rod which connects the handbrake lever to the bell crank attached to the chassis. You need to remove this as well. The bell crank can stay in place, but it is not used with the X-Brake.

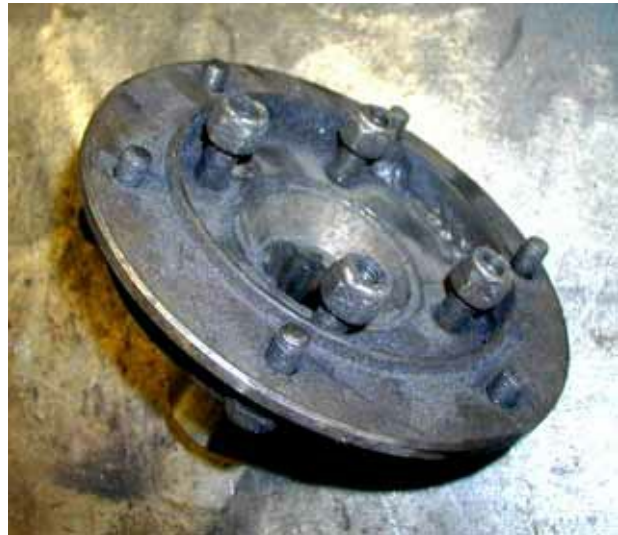
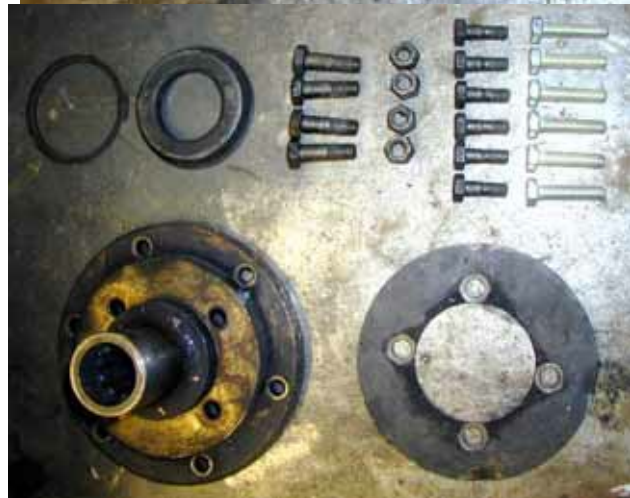
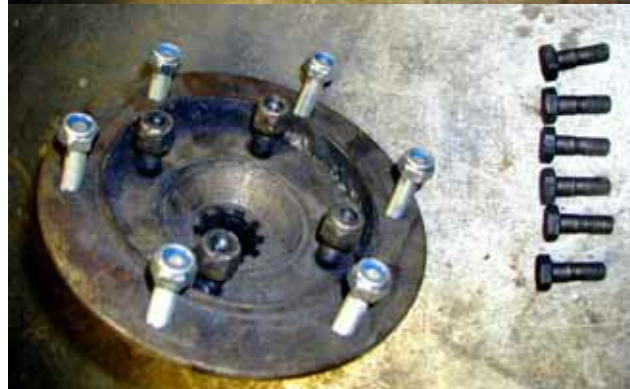
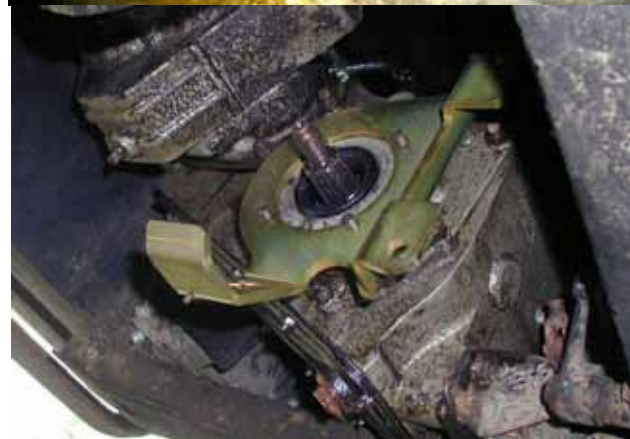
The Drum Brake back plate bolts were secured with lock-washers. The new back plate is a bit thicker and the mounting studs are not long enough.

The bottom bolt in the photo has the lock-washer in place and you can see the nut cannot screw fully on to the stud.

Remove the lock washers and use thread-lock to secure the nuts on to the studs.

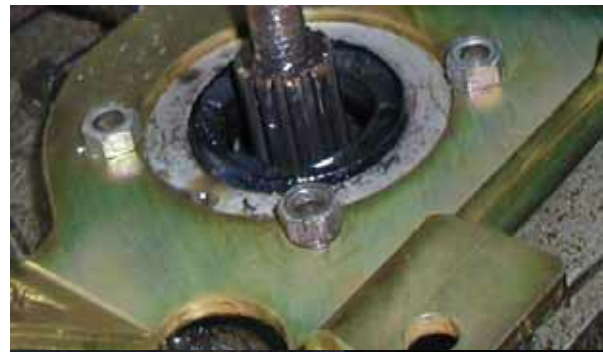
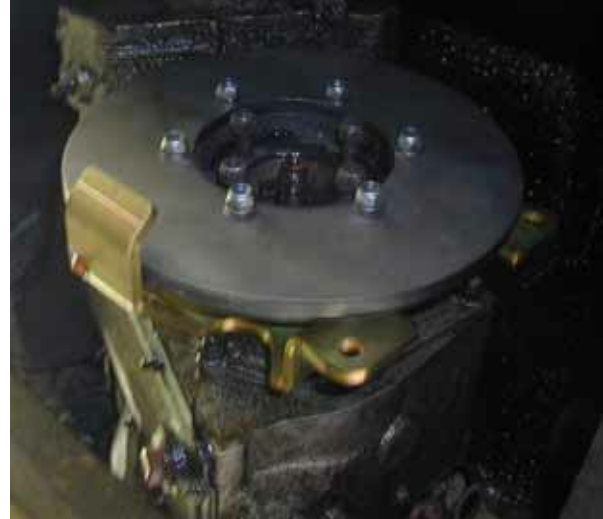
Fit the drive flange to the transfer box output shaft and once in place, slide the new disk rotor on to the six M8 bolts.

You can tighten the M8 bolts at this stage using a pair of 13mm spanners.

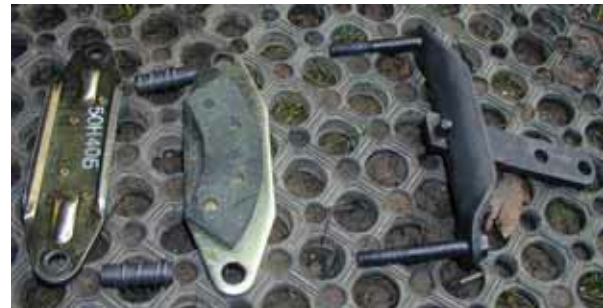
Disassemble the brake calliper as shown. It will need to be assembled in-situ on the back plate.

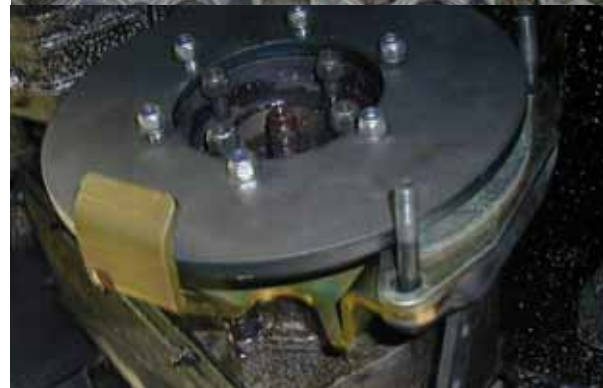
Insert the front pad (the one with the bigger holes) between the disk and back plate. Next slide the operating lever and bracket with its bolts through the back plate and pad as shown

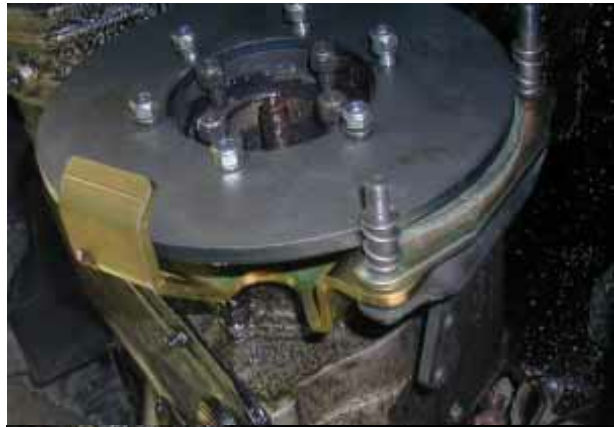
Next slide the spacer tubes and springs over the two bolts, through the holes in the pad and back plate.

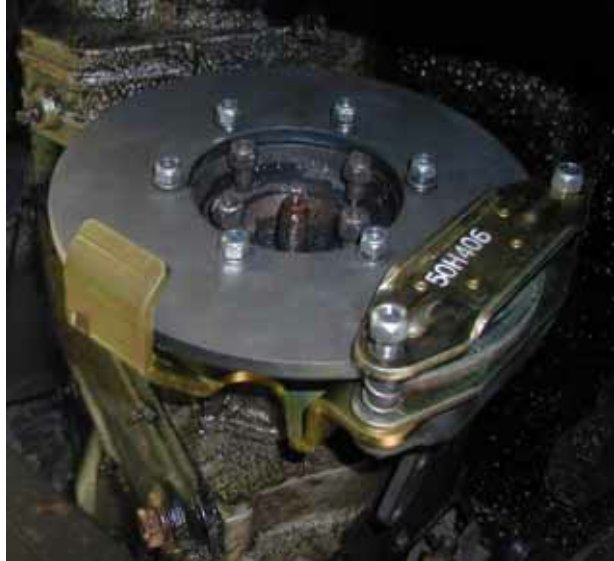
You can then slide the rear pad over the bolts and screw the nuts on to the bolts.

You can tighten these, and the disk rotor bolts to about 20 Nm.

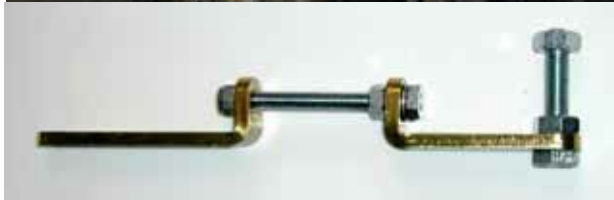
Assemble the new adjuster / push rod as shown in the photo.

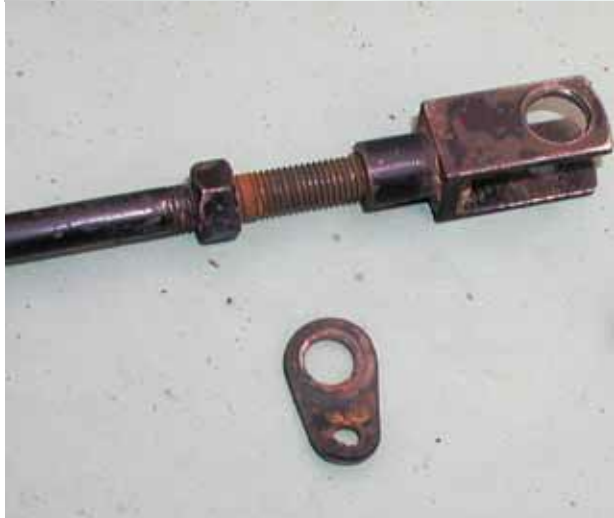
You will already have removed the original push rod. Unscrew the clevis from the end and remove the tab to which the tensioning spring attaches - we will need this soon.

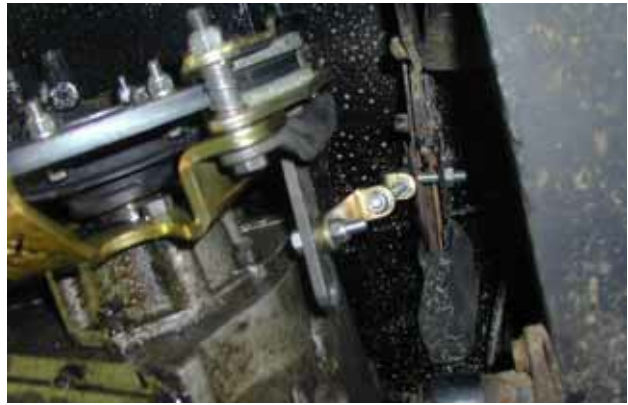
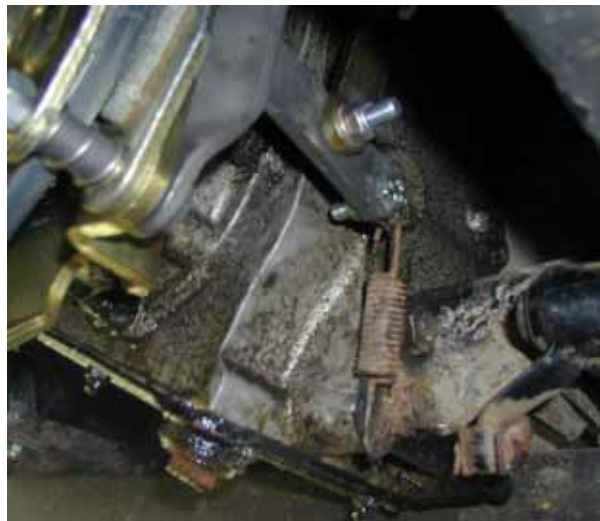
Pass the M10 bolt on the end of the new adjuster through the hole in the handbrake lever vacated by the old push-rod. This is often a bit tight and needs a bit of wiggling.

Using an M8 bolt (supplied), secure the lower end of the adjuster to the inner hole in the calliper operating lever. Tighten both the M8 and M10 bolts, then back them off $\frac{1}{4}$ turn so the adjuster is free to rotate, but not to rattle.

Now use the remaining M8 bolt to secure the spring tab (from 2 steps ago) to the outer hole on the calliper operating lever.

Stretch the original spring between the tab on the calliper lever and the tab on the gearbox mounting bolt. Adjust both such that the spring is under tension when the brake lever is released.

This is most important in stopping the pads rubbing on the disk and preventing it from rattling!

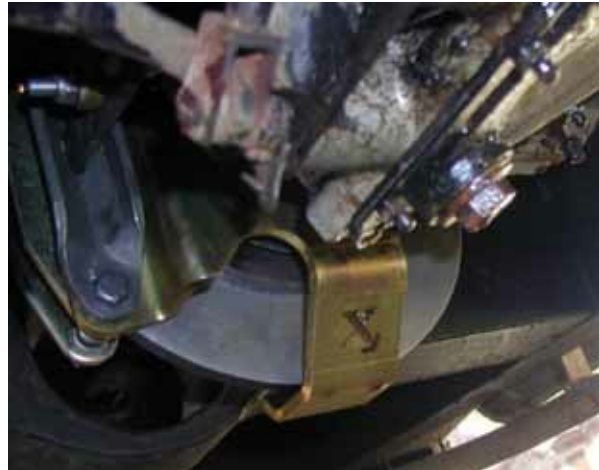
With the operating lever released, using a deep socket, tighten the nylock nut on the adjuster bar until the point where you can just wiggle the pads by hand and if you push the calliper lever up by hand, you can easily move it a few millimetres before the pads tighten on the disk.

The operating lever should start to feel tight at 50 to 75% of its full travel.

If it is less than this, the pads will rub on the disk and overheat. If it is more, you will not achieve the maximum potential braking efficiency.
